# Blu Mint Building Inspections

## SITE AUDIT REPORT

### Riverside Apartments — Block C

| Location: | 42 Wharf Road, Pyrmont NSW 2009 |

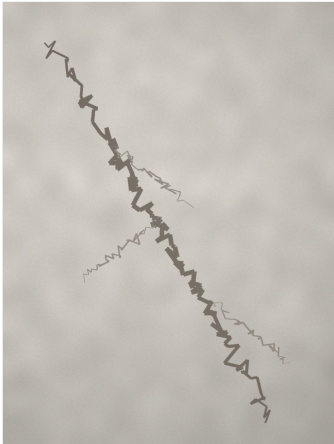
Cracked render to external wall

Full extent of the crack from window head to slab

Vertical crack approx. 1.4 m running from the window head down to the slab edge. Widest point roughly 3 mm. Needs cutting out, re-rendering and repainting to match.

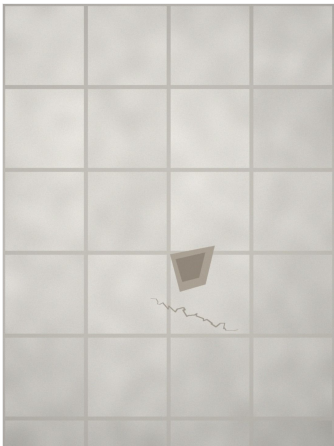
Chipped tile at main entry

Chipped corner, entry threshold

Corner chip to floor tile directly inside the entry door. Trip and cut hazard in a high-traffic area. Replace tile and re-grout.

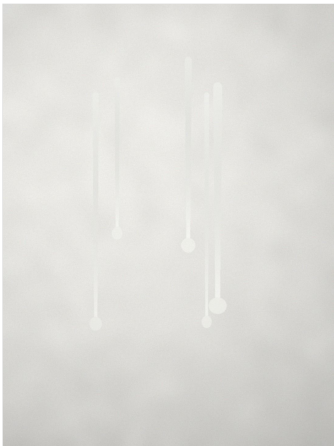
Paint runs to corridor wall

Runs visible in raking light

Several runs and sags in the topcoat along the eastern corridor wall. Sand back and reapply finish coat.

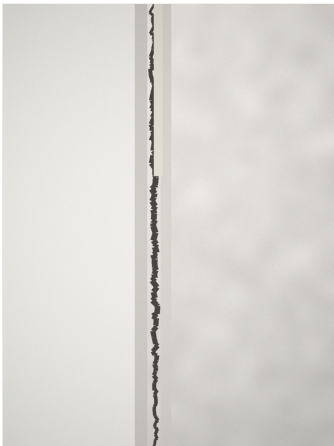
Window perimeter seal incomplete

Gap where the sealant run stops

Sealant to the window reveal stops short of the sill on the western side, leaving an open gap. Water ingress risk. Rake out and reseal the full perimeter.

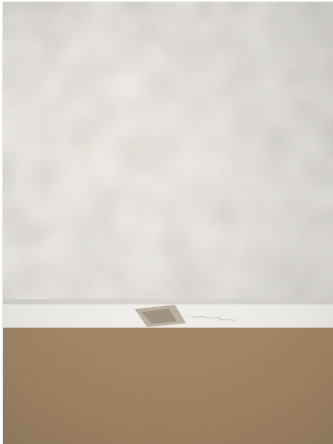
### Skirting damaged behind door

*Gouge to skirting face*

Gouge to the skirting where the door has been swinging back without a stop. Fill, sand and repaint; door stop to be fitted.

Filled, sanded and repainted. Door stop fitted to prevent recurrence.

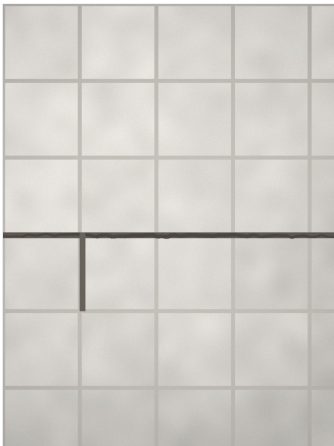
Grout missing to shower base

Open joint at the base junction

Grout absent along the junction between the shower base and the wall tiles for roughly 800 mm. Re-grout and seal.

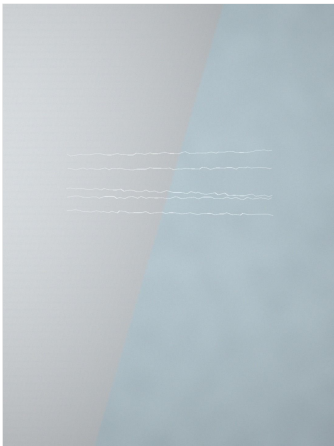
Scratches to balcony glazing

Scratches across the balustrade panel

Two long scratches across the balustrade glass, visible from inside. Panel to be replaced under warranty.
